AE monitoring and structural modelization of the Asinelli Tower in Bologna

SUMMARY. The Acoustic Emission (AE) technique was used to assess the structural stability of the Asinelli Tower, the tallest building in the city of Bologna, which, together with the nearby tower, named Garisenda, is the renowned symbol of the city. AE is a passive, non-destructive structural evaluation technique based on the spontaneous emission of pressure waves by evolving fracture processes. The monitoring program was carried out with the aid of a USAM tool, which is part of the equipment used at the Fracture Mechanics Laboratory of the Department of Structural Engineering at the Politecnico di Torino. This tool makes it possible to conduct a complete analysis of AE signals, acquire a huge quantity of data from on site monitoring, and identify the microcracks triggering the damage processes in a structure.

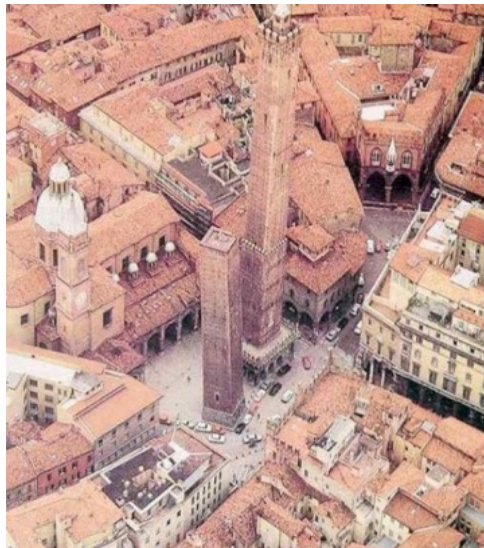
Figure 1. The Asinelli Tower and the Garisenda Tower in the city center of Bologna.

The Asinelli Tower rises to a height of 97.30 m above the ground. It has a square cross-section, tapering along its height, the sides measuring ca 8.00 m at the base and 6.50 m at the top. From the structural standpoint, the tower can be subdivided into four segments, depending on type of masonry. The thickness of the walls varies from 3.00 m at the foundations to 1.00 m at the top. The first segment, at the base of the tower, is made entirely of selenite blocks. It starts at a depth of ca 1.70 m below ground level and rises to 3.00 m above ground. The substructure of the tower is nearly square, with sides approx. 10.50 m long. The second segment, with sides tapering from 8.15 m to 7.70 m, rises to a height of 34.20 m. The third segment, which constitutes the upper part of the tower and contains the merlons added in the fifteenth century, has sides that gradually decrease in size to ca 6.50m at a height of 81.25 m above ground level. The masonry of the second and third segments is a sacco, i.e., consists of an outer and an inner face, 90 cm and 45 cm thick respectively, enclosing a mixture of rubble, bricks and mortar – and is characterised by an overall thickness of 2.80 m. At the base, up to a height of 8.00 m, the tower is surrounded by an arcade built at the end of the fifteenth century.

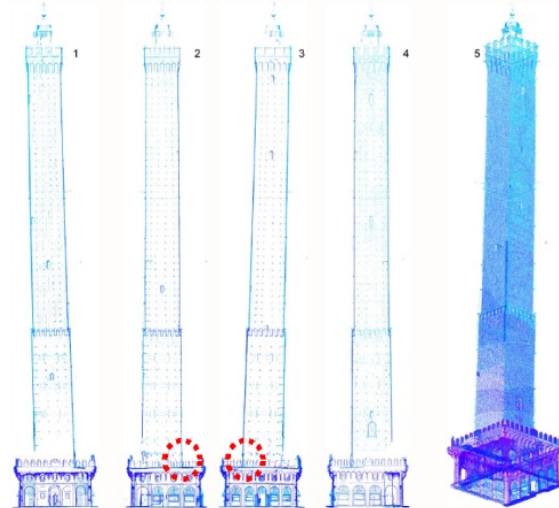
Figure 2. Front views and axonometric view of the Torre degli Asinelli. These views, supplied by the Municipality of Bologna, are taken from the measurements of the exterior of the structure made by Prof. Alessandro Capra by laser scanning. Faces (1) South; (2) East; (3) North; (4) West; (5) Axonometric view. The transducers were applied to the north-east corner of the tower, in the zones marked with a circle.

The studies conducted in the early twentieth century by F. Cavani [8] revealed that the Asinelli Tower leaned westward by 2.25 m; this is the reason why it is known as the tallest leaning tower in Italy. The latest measurements, made in 2009 by Prof. A. Capra by laser scanning, on behalf of the municipality, showed an overall inclination of 1.51 degrees and a deviation from verticality of 2.38 m. Thus we find that the deviation increased by 13 cm in the course of approx. one century, that is to say at an average rate of 1.30 mm/year. Figure 1 shows the Asinelli Tower and the adjacent Garisenda Tower in the city center of Bologna. Figures 2 and 3 show the front elevations and the cross-section of the Asinelli Tower and a plan view indicating the zone of application of the AE sensors.

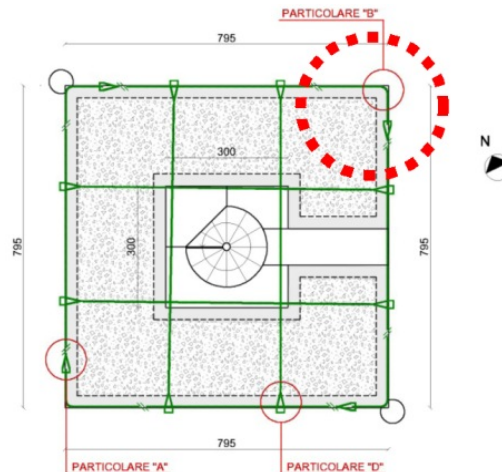
Figure 3. Cross-section of the tower at a height of ca 10 m above ground. Drawing supplied by the Municipality of Bologna. The corner where the sensors were applied is marked with a circle.

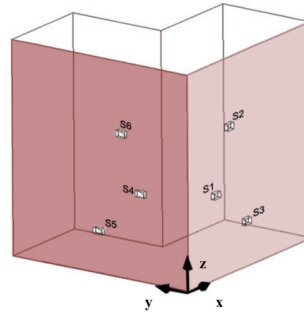
Figure 5. Axonometric scheme of the points of application of the AE sensors at the north-east corner of the tower.

The coordinates of the sensor application points are given in Table 1. The origin of the coordinate system of reference, as can be seen in Fig. 5, is at the bottom corner of the masonry at the intersection with the outer surface of the terrace surrounding the tower.

Sensors	x	y	z
S1	51.50	0.00	98.00
S2	78.00	0.00	171.0
S3	110.00	0.00	53.00
S4	0.00	63.50	102.00
S5	0.00	121.06	50.00
S6	0.00	89.00	167.00

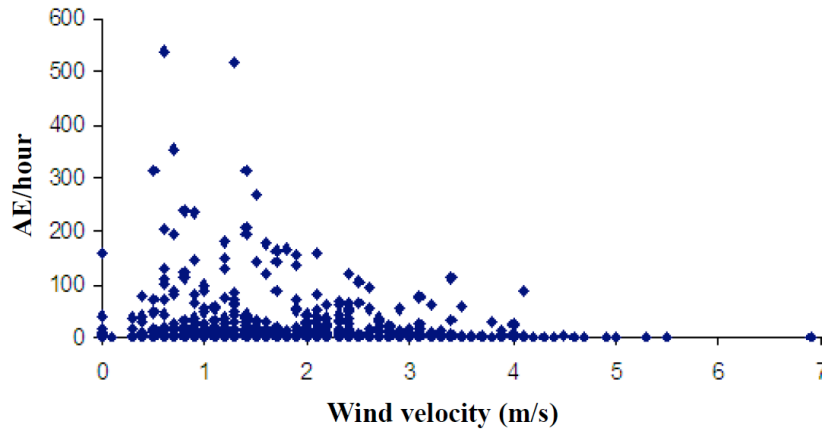
Figure 10: Chart relating the wind velocity and the AE count rate during all the monitoring time, the two time series seem to be statistically unrelated.

Moreover, the chart of Fig 10 relates the wind velocities and the AE count rate obtained during all the monitoring period (2915 hours). This graph makes clearer that the two phenomena are completely statistically unrelated.

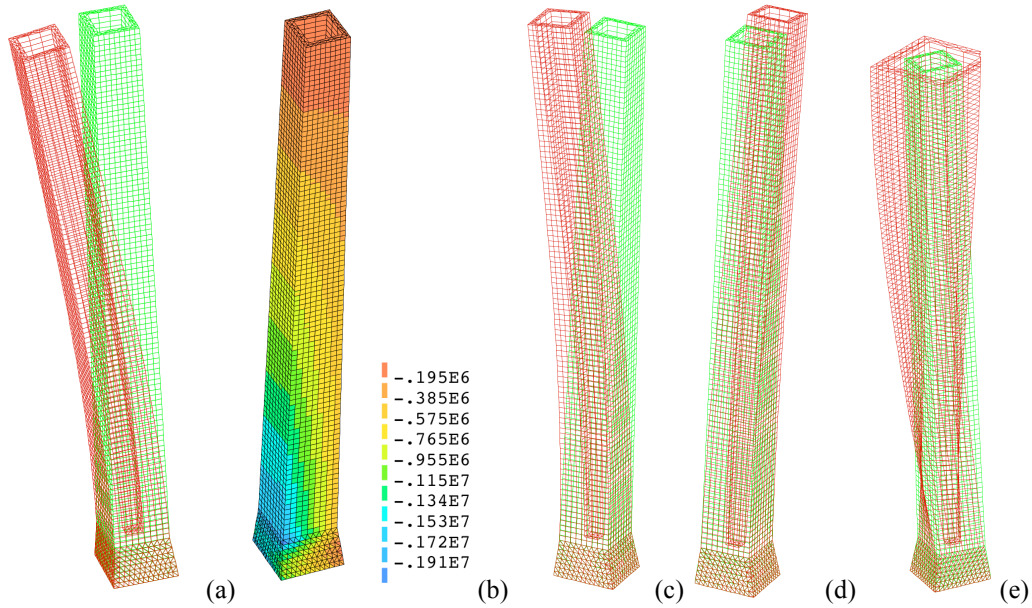
Figure 11. Deformation due to the effect of gravity (a); vertical stress expressed in MPa (b); first modal shape (c); second modal shape (d); fifth modal shape (e).

The preliminary linear elastic analysis considered only the self-weight of the tower (Fig. 11a). It was possible to assess that the elastic deformation of the tower is about 8 cm, which is about 1/30 of the present total deviation from verticality.

The level of stress in the masonry of the tower (Fig. 11b) is generally low, although in proximity of the monitored area, the level of vertical stress approach 2.1 Mpa, which can be critical in case of very poor masonry.

The preliminary modal analysis showed that the first mode is bending in the west-east plane, with a resonance frequency of 0.357 Hz (Fig. 11c). The second mode is bending in the orthogonal plane, with an eigen-frequency equal to 0.365 Hz (Fig 11d). The third eigen-frequency is 1.75 Hz, and the fourth is 1.78 Hz. The fifth mode is torsional (Fig. 11e) with an eigen-frequency of 3,07 Hz. Those results agree quite well with more detailed dynamic analyses carried out by other Authors [11].

The maximum vertical stress in the tower is compatible with the acquire rate of acoustic emissions from the monitored region. The fact that the first modal shape tends to increase the stress in the same area agrees well with the increase of acoustic emissions connected with seismic events.
